FINAL REPORT

Spring Mission: February 27, 2009 – April 10, 2009

Luigi De Cesaris & Alberto Sucato, Restorers

“Conservation and Documentation of the Wall Paintings at the Red Monastery, Sohag”

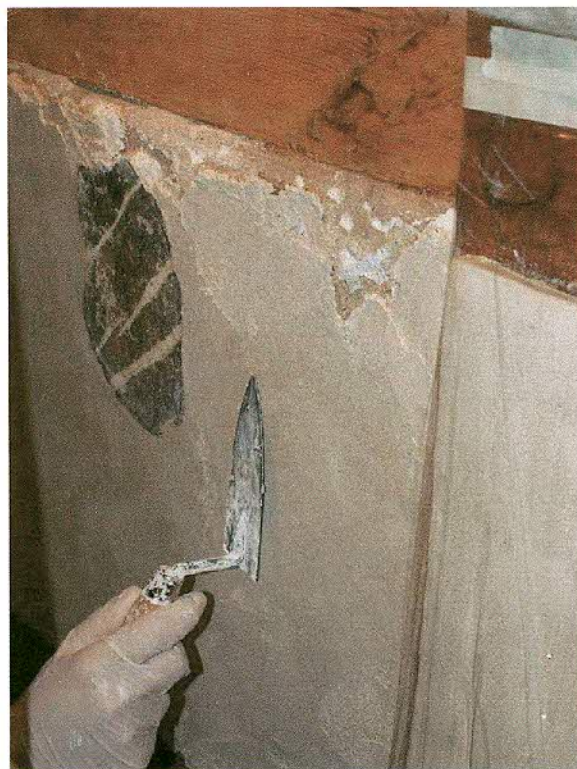
Fig. 69

The repairs to the plaster were applied in coats, using a mix with medium-sized grains to fill gaps and finer grains on the surface. This kind of work proved necessary on the north and south sides of the first tier of the facade (F). These repairs were made extremely smooth for aesthetic reasons, as well as to give them particular mechanical resistance in areas where the passage of worshipers could cause further damage (Fig. 69).

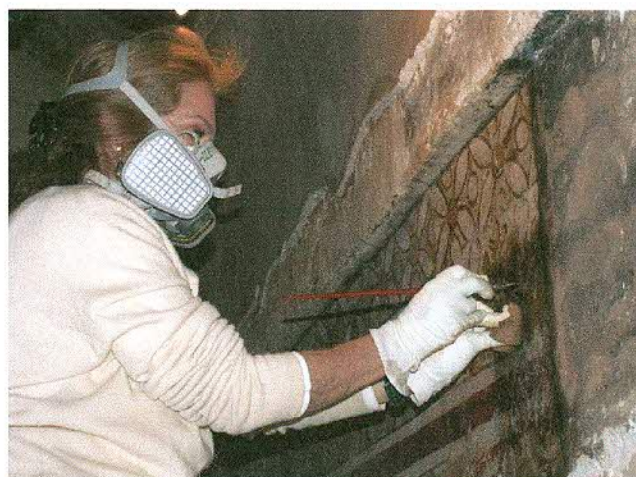
Fig. 72

The system developed has shown itself to be effective and safe with regard to the constituent materials and to reduce mechanical stress on the painted surface. The cleaning system involves, in the first place, the use of organic solvents applied using Japanese paper and several single-ply paper tissues to dissolve the substances on the surface (oil- and resin-based varnish). To all intents and purposes, this is a process of stripping. Next, sooty deposits, oily residues and thin layers of saline efflorescence are removed using a slightly basic solution of inorganic salts applied on several thicknesses of paper tissue and working in small areas at a time (Figs. 71, 72 and 73). Thicker layers of saline efflorescence are removed mechanically using a scalpel.

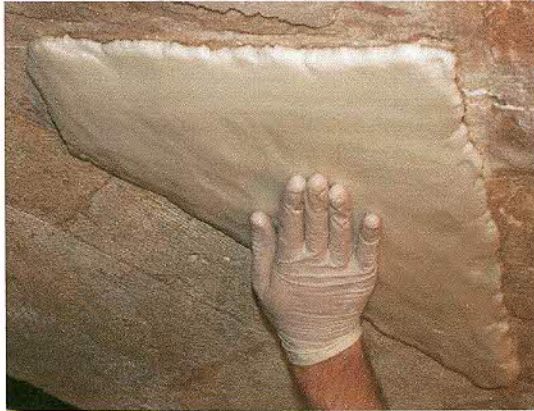
Fig. 76

The cleaning of the stonework required a system different to that used for the plaster. Owing to the nature of the local limestone, the sooty residues and particulate matter were particularly ingrained in the pores of the stone, creating consolidated deposits over wide areas. To clean them we decided to use the same solvent mixture used for the plaster types but applied in a different way. Wood pulp was used as a support since its tixotropic properties allow longer application times without the danger of excessive impregnation of the substrate (Figs. 76 and 77).

Application times varied from 7 to 20 minutes depending upon the thickness and resistance of the layers of dirt and incrustation to be removed.

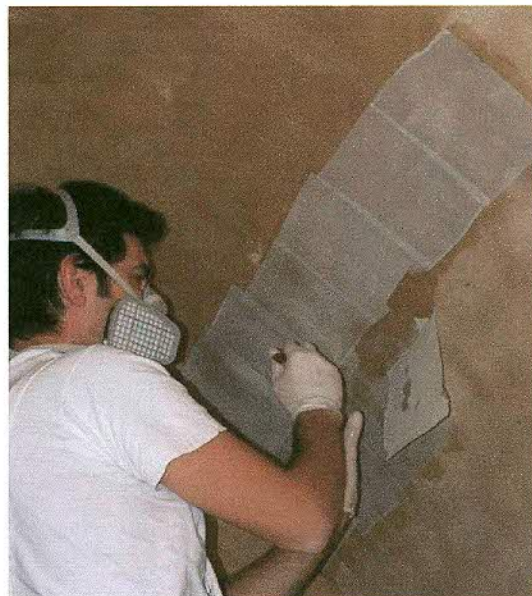
Fig. 78

Once the wood pulp was removed the surface was rinsed using sponges and soft-bristled brushes. In one area alone, at the base of the pilasters giving access to the north corridor (NEB) it proved necessary to carry out a one-off pre-consolidation before cleaning could take place as a result of serious state of exfoliation of the limestone. The same inorganic salt mixture described above was used for the unpainted plaster, but in this case it was applied using several paper tissues placed one on top of the other (Fig. 78). Once removed, the surface was well rinsed using sponges and sprayers (Fig. 79).

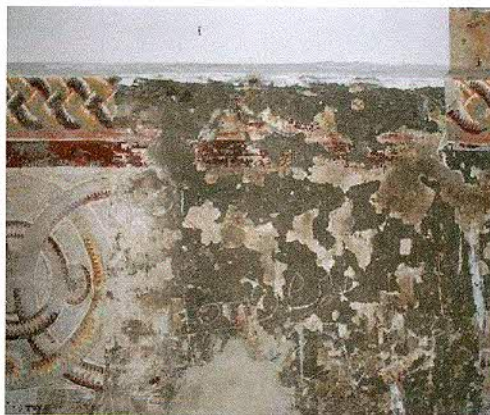
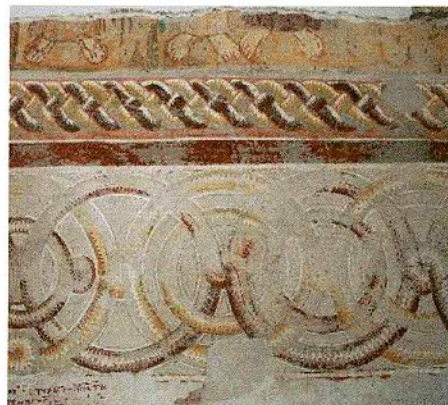
In the north corridor (NEB) a one-off procedure to remove the wash, as described in detail in the 2008 report²⁹, was needed to reveal completely the pattern of large circles running along the south wall (Figs. 84 and 85).

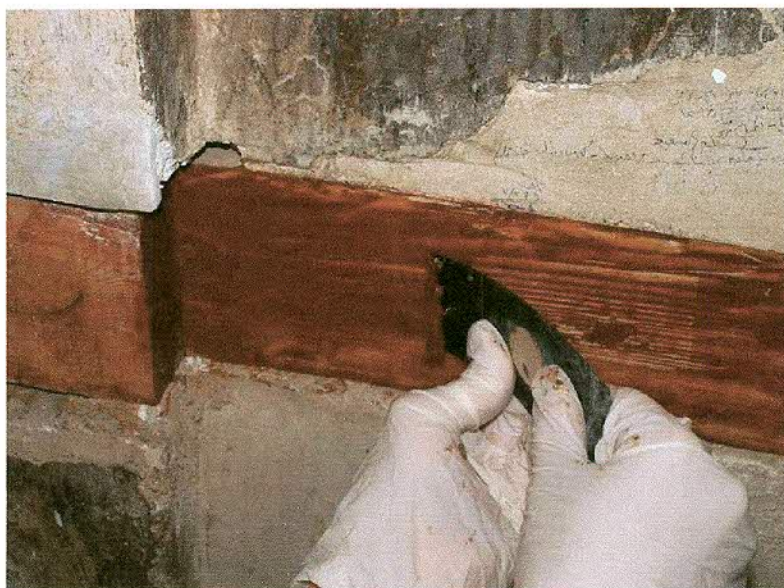
Fig. 90

The paint was removed from the woodwork using a mixture of organic solvents (nitro diluent and acetone) (Fig. 90). The woodwork was treated with a permethrin-based product (XIREIN) to treat it against attack by insects and then protected with acrylic resin in a 3% nitro diluent solution (PARALOID B72).

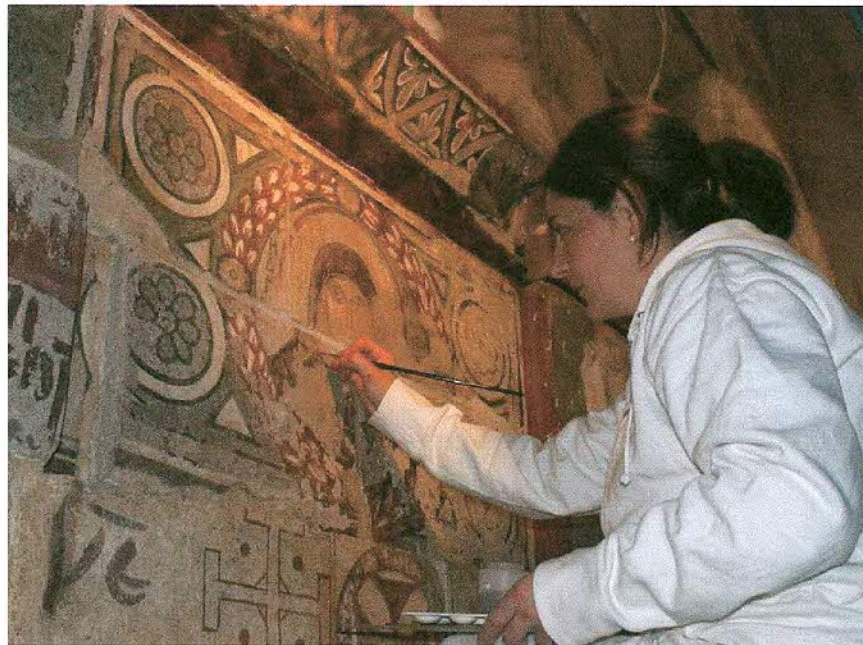
Fig. 91

The gaps in the paint layer were blended in using the technique of toning down with watercolors (WINDSOR & NEWTON). This technique restores legibility to the artistic palimpsest and painted surface and clarifies the reading and order of the different paint layers that can be seen³⁰.
